INNOVATIVE METHODOLOGY FOR DETECTION
OF
FRACTURE-CONTROLLED SWEET SPOTS
IN THE
NORTHERN APPALACHIAN BASIN

TOPICAL REPORT #9

This Topical Report (#9 of 9) consists of the figures 3.8-1 to (and including) 3.9-5 (and appropriate figure captions) that accompany the Final Technical Progress Report entitled: “Innovative Methodology for Detection of Fracture-Controlled Sweet Spots in the Northern Appalachian Basin” for DOE/NETL Award DE-AC26-00NT40698.

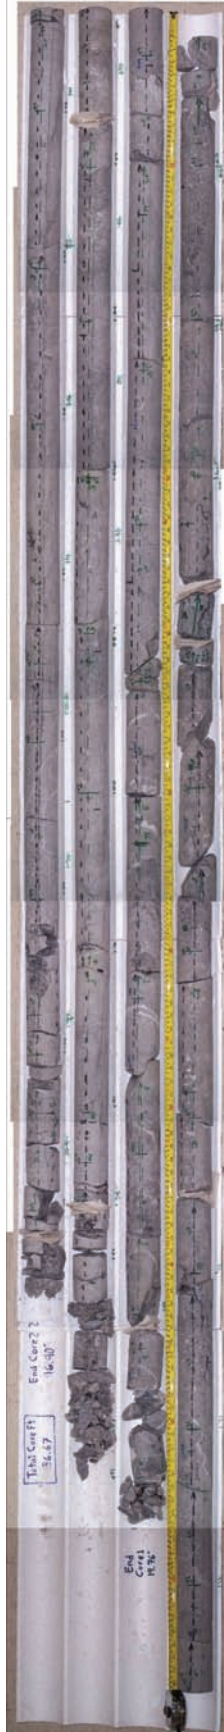
FIGURE 3.8-1

FIGURE 3.8-1. Reassembled, Oriented, Horizontal Core from the Black River in Central New York State.

Rotation of individual core segments were rotated to match FMI log.

FIGURE 3.8-1. Reassembled, Oriented, Horizontal Core from the Black River in Central New York State.
